TECHNICAL SERVICE BULLETINS

**SERVICE BULLETIN****APPLICABILITY:** STi Vehicles, All Model Years
SUBJECT: Towing Recommendations**NUMBER:** 01-162-05
DATE: 06/28/05**INTRODUCTION**

APPLICABILITY: All Models
SUBJECT: Cylinder Head Gasket (residual carbon deposits and rubber coating removal)

NUMBER: 02-100-06R
DATE: 10/31/06

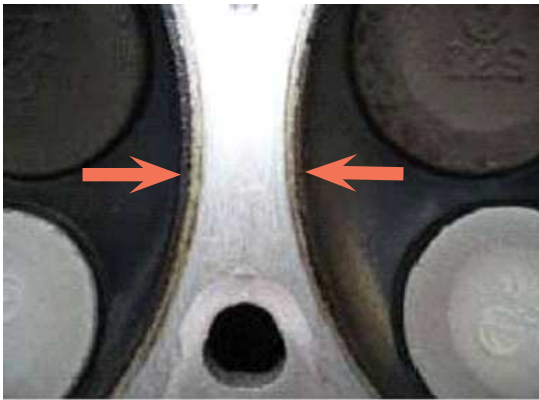
Accumulated carbon deposit on
bore sealing portion

Using a gasket scraper, carefully clean any carbon deposits and rubber coating found on the surface of cylinder block and cylinder head.

CAUTION: Keep the scraper as flush as possible to the surface to avoid damage to the mating surface of cylinder block and cylinder head.

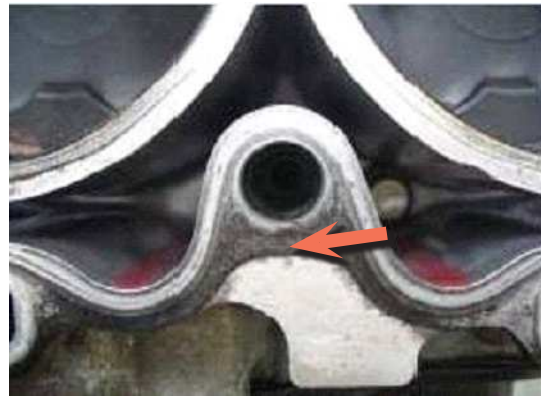
Rubber coating residue on coolant sealing portion

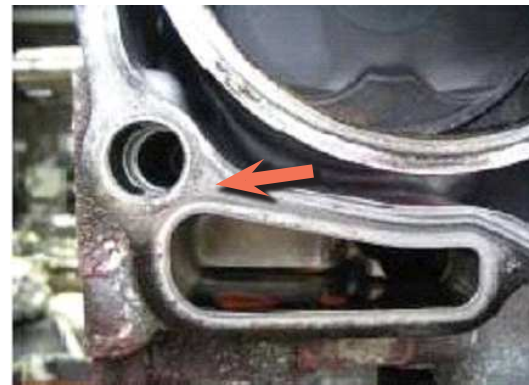
Rubber coating residue on oil sealing portion

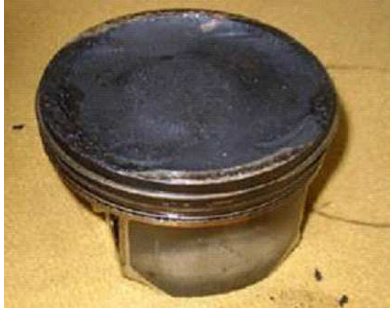
Modifications to the Engine Ignition System, such as “plugs”, can cause abnormal ignition, and result in engine damage.

Ring Land Damage from Detonation

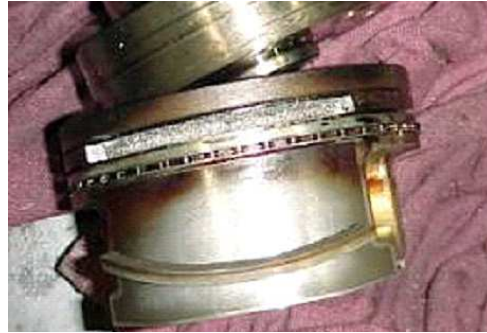
Ring Land Broken from Over Boosting

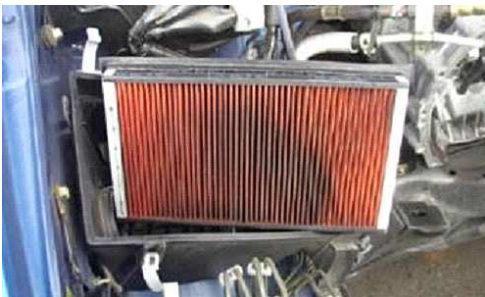
If the air cleaner element is contaminated, intake air flow is reduced. This condition will create an increase in engine vacuum causing an extra load on the turbo charger.

Contaminated Air Cleaner Element

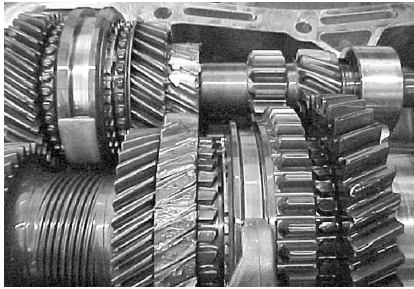
Second Gear Teeth Missing

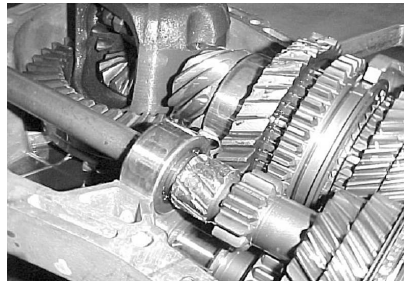
First Gear Teeth Stripped from Mainshaft

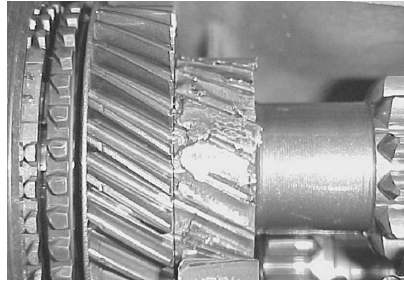
Second Gear Teeth Missing

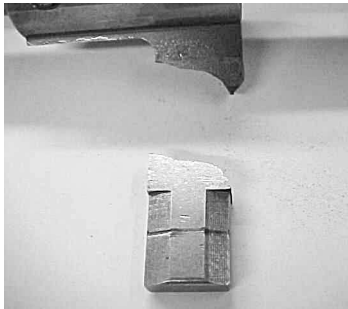
6-Speed 1-2 Shift Interlock
Arm Broken

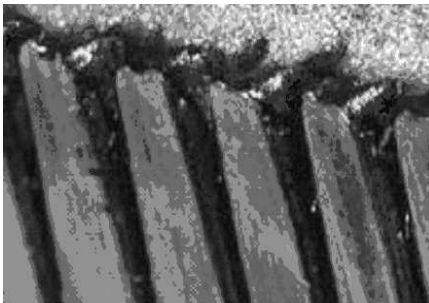
Damaged Land of Baulk Ring

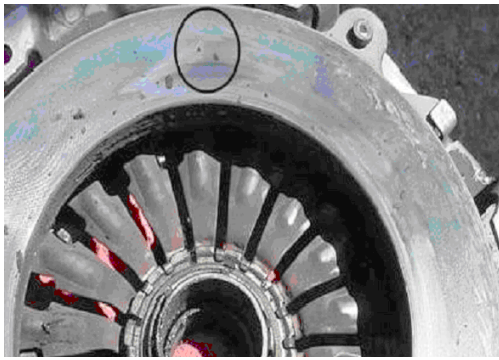
Over Heated Pressure Plate

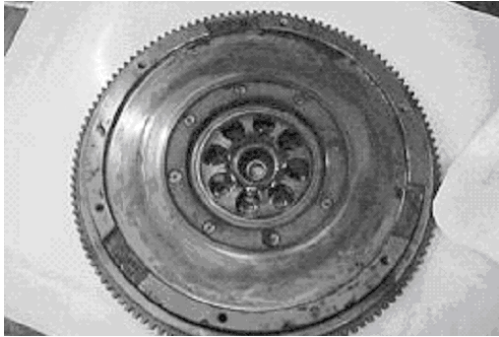
Over Heated Flywheel

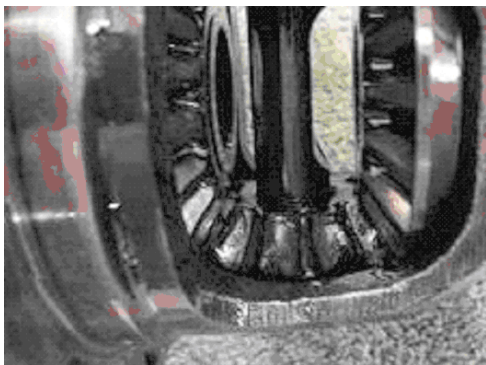
Rear Differential Gear Damage

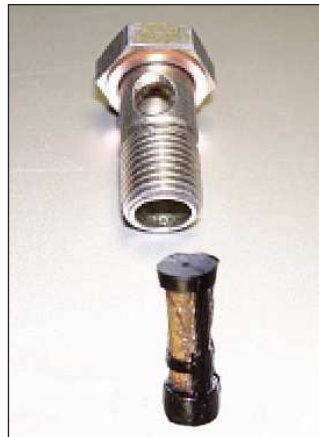
**Banjo bolt and Mesh Screen
 (note direction of screen)**

- Make sure the mesh screen is installed in the proper direction; incorrect installation will cut off oil supply to the turbo.

In addition, the mesh screen which is located inside the banjo bolt that secures the turbocharger oil supply pipe to the back of the right side cylinder head should be checked to make sure it is not clogged or restricted especially if the condition of the oil is questionable or as to when the last oil change was performed. If clogged or restricted, it will reduce or cut off the oil supply to the turbo resulting in failure. The oil supply pipe should also be checked to make sure that there are no obstructions. *Note: The mesh screen is only available with a replacement banjo bolt.*

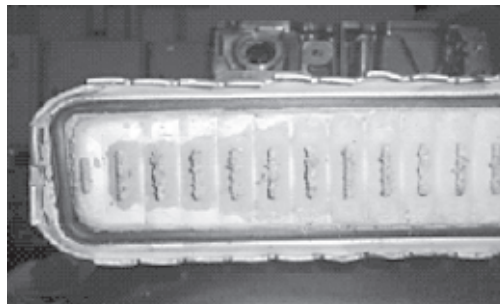
This photo shows the condition of a clogged radiator that has been filled with non-genuine coolant. The residue is corroded aluminum.

Whenever the coolant is changed, you must add Genuine Subaru Cooling System Conditioner. Genuine Subaru Cooling System Conditioner has been tested and approved for aluminum engines and radiators.

Do not use after-market coolant reinforcement agents, sealers and/or flushing agents as those chemicals could corrode aluminum parts.
